DEEP-OCEAN BIODETERIORATION
OF MATERIALS — PART VI. ONE
YEAR AT 2,370 FEET

U. S. NAVAL CIVIL ENGINEERING LABORATORY
Port Hueneme, California

Technical Report R-525

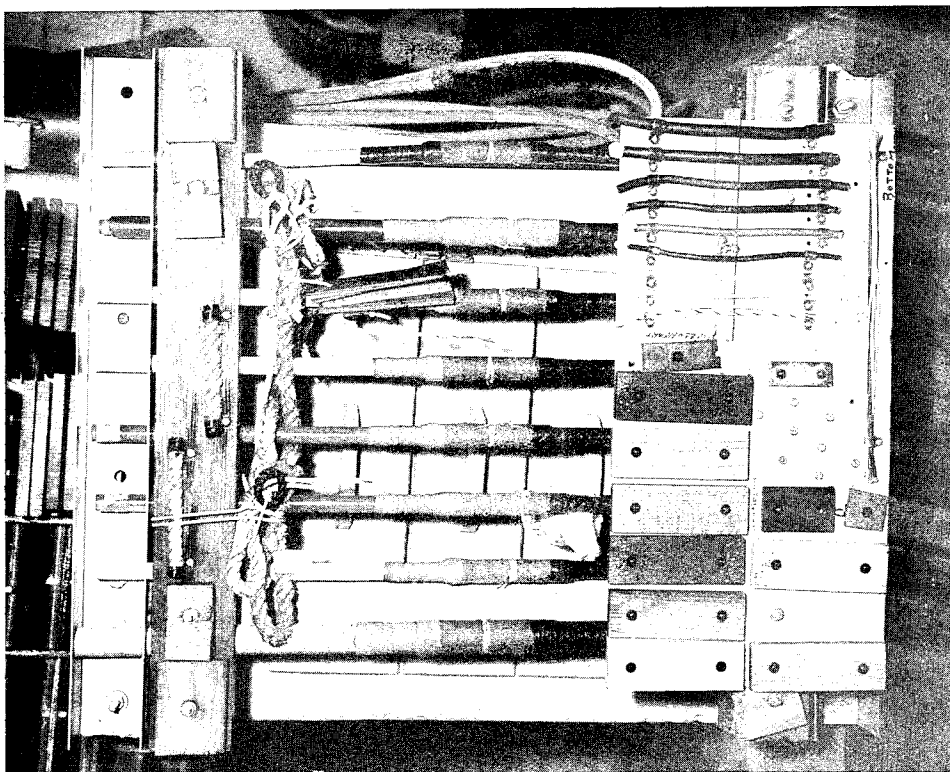
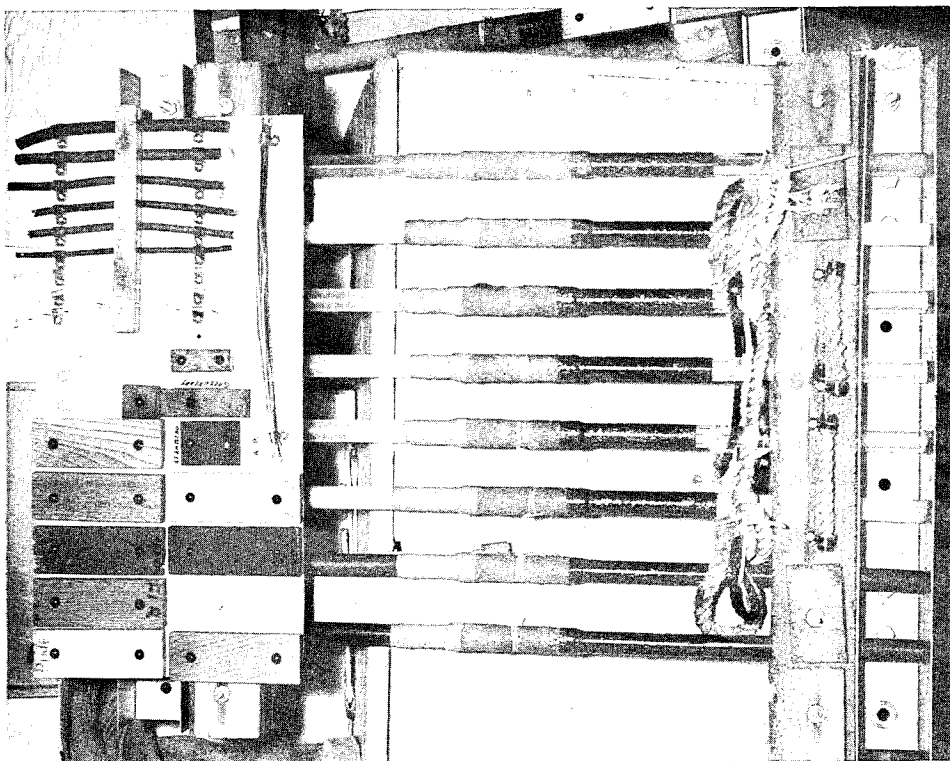
As soon as the STU was secured to the deck, the bio-racks attached to the side of the STU were disassembled (Figure 6). The individual test specimens were placed in plastic bags for later examinations, tests, and evaluation in the laboratory.

Figure 6. Bio-racks immediately after recovery from the sea. Compare with Figure 3.

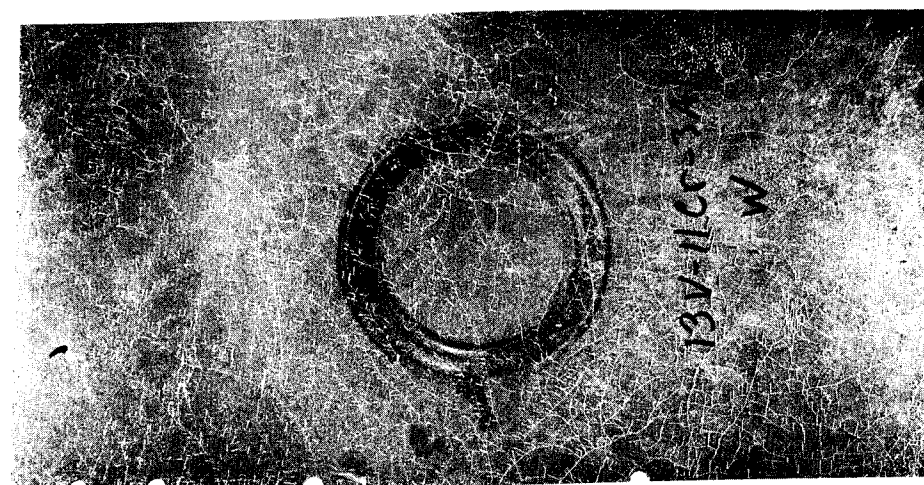
Figure 8. Hydroid growth on titanium test panel.

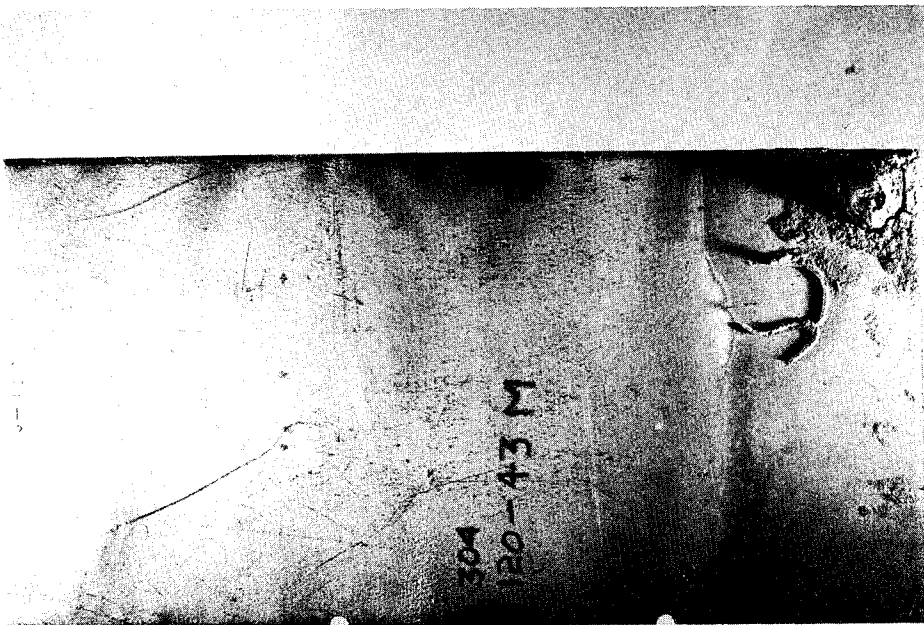
Several tubeworms (3-inch-long tubes made of mud and bottom debris) were found on stainless steel panels which were partially buried in the sediment (Figures 9 and 10). Another variety of tubeworms (tubes made of white calcareous materials) were found on stainless steel and titanium panels (Figure 11). A small pecten about 1/8 inch in diameter was also found attached to a titanium panel which was partially buried in the sediment (Figure 12). Several deep sea crabs (Figure 13), gastropods (Figure 14), and a large sea anemone (Figure 15) were found on various test panels.

Figure 9. Tubeworm on a bottom section of a stainless steel panel exposed in the sediment.

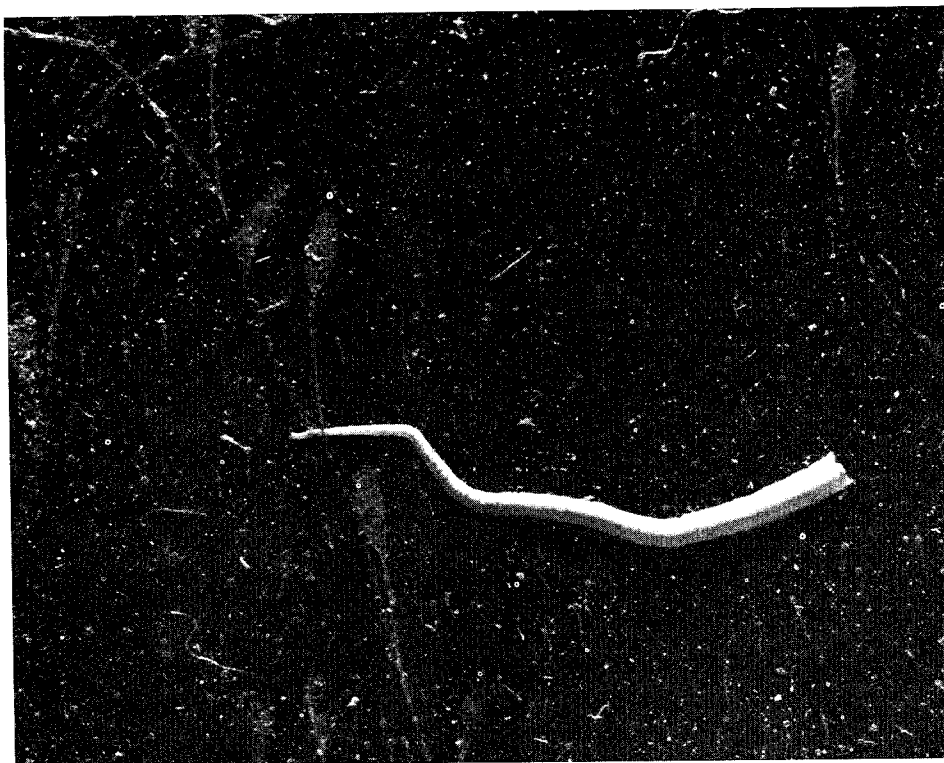
Figure 11. Closeup view of a tubeworm on a titanium test panel.

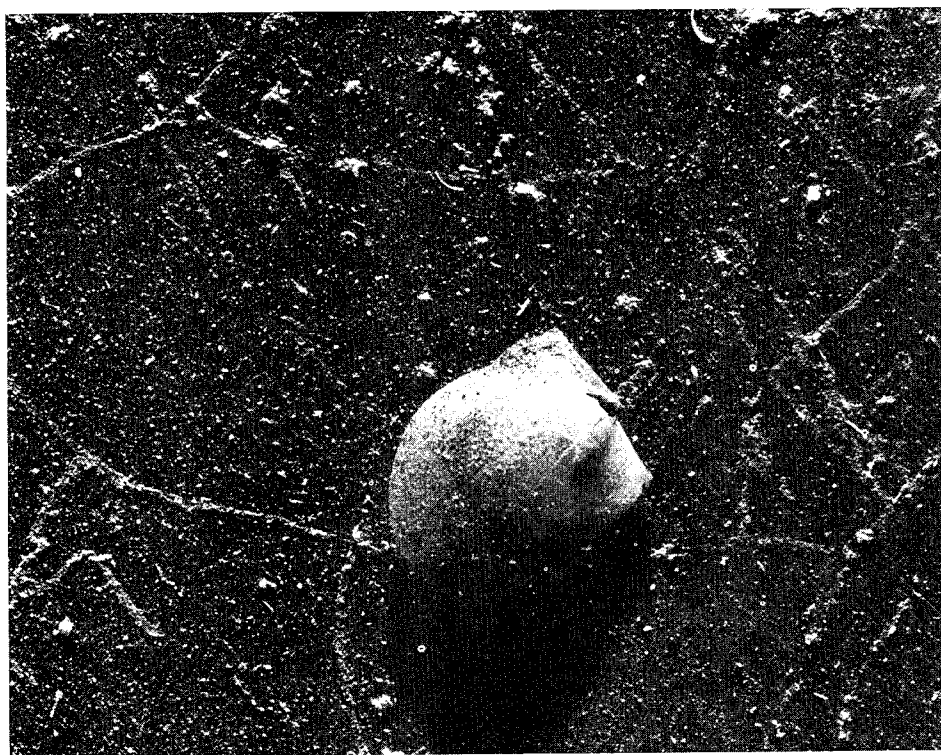
Figure 12. A 1/8-inch-diameter pecten growing on the surface of a titanium panel.

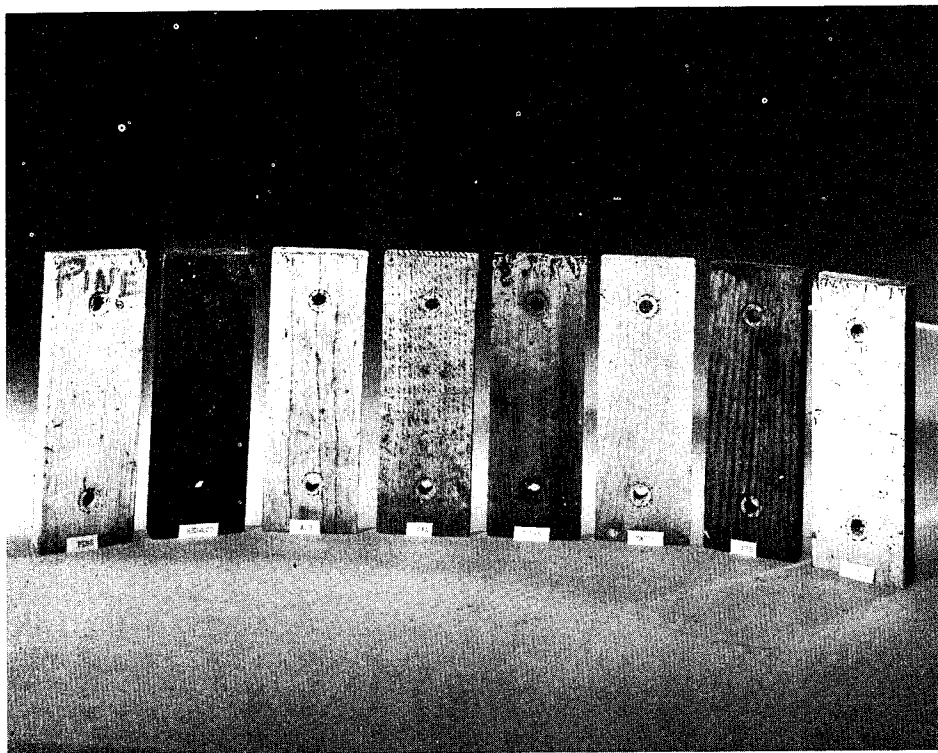
Wood Panels. Various kinds of untreated wood panels (1/2 x 2 x 6-inch) such as pine, fir, ash, maple, cedar, oak, and redwood were exposed to determine the effects of marine organisms on different woods. All the wood panels were attacked by marine borers and sustained light to heavy damage. Redwood and cedar were the most severely damaged; maple, pine, oak, and ash were moderately damaged; and fir sustained the lightest damage (Figures 16 & 17).

Figure 16. Various types of wood panels (exterior).

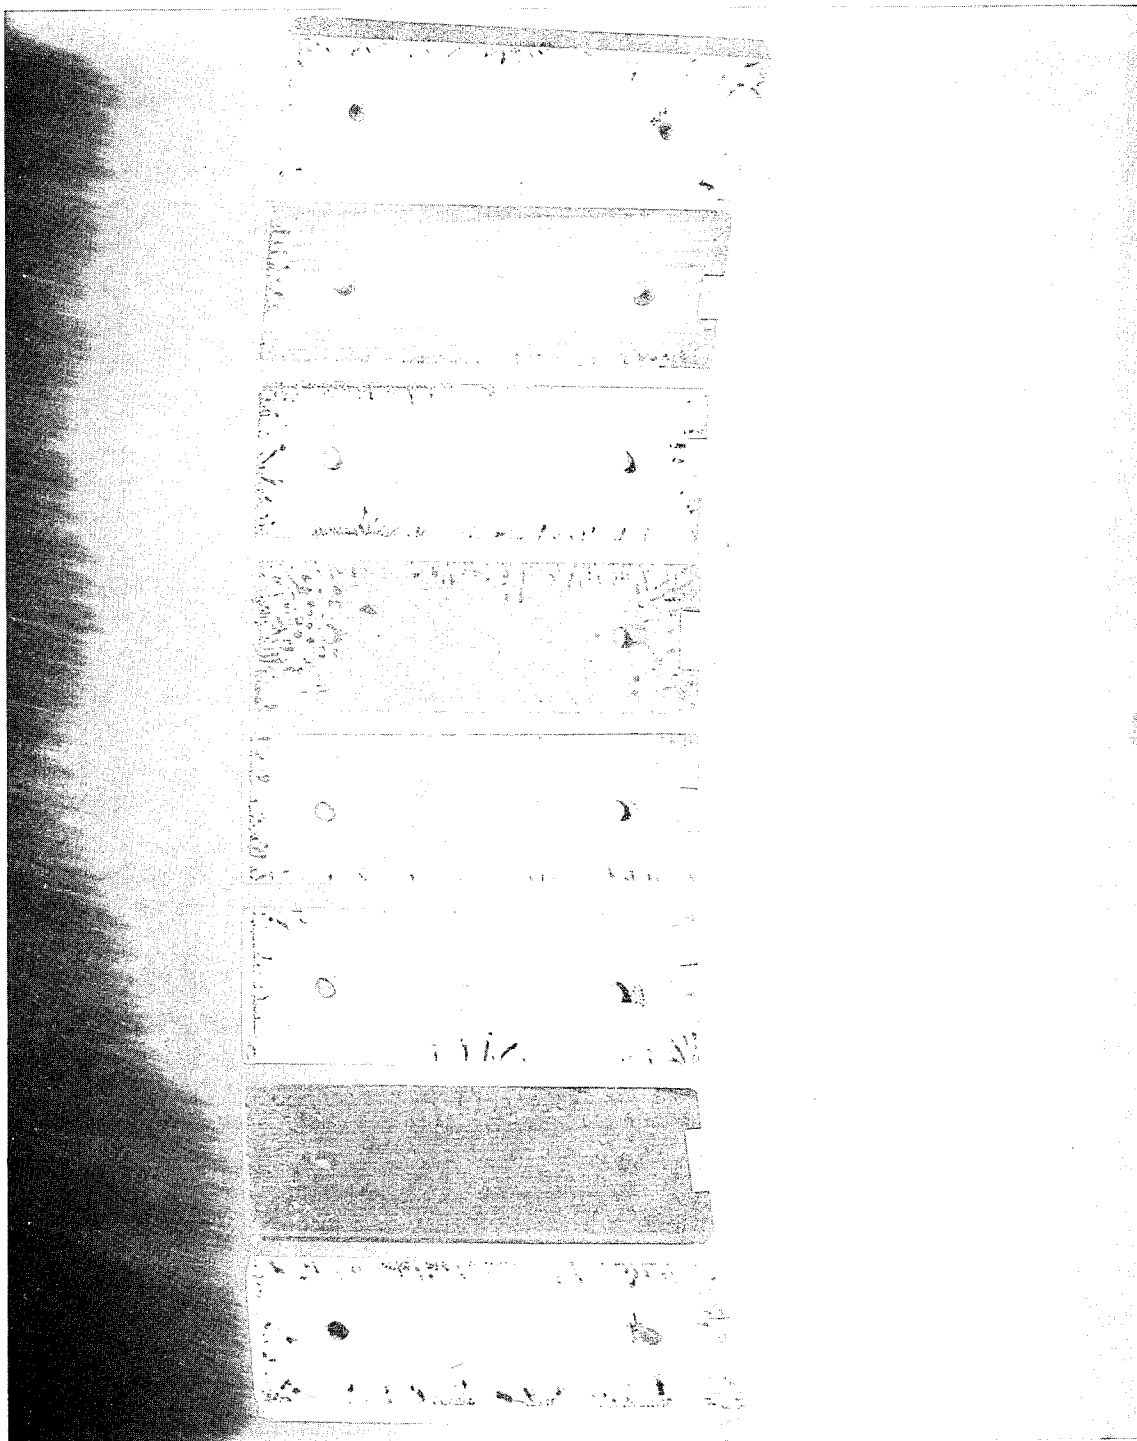
Figure 17. Same wood panels as shown in Figure 16 (interior).

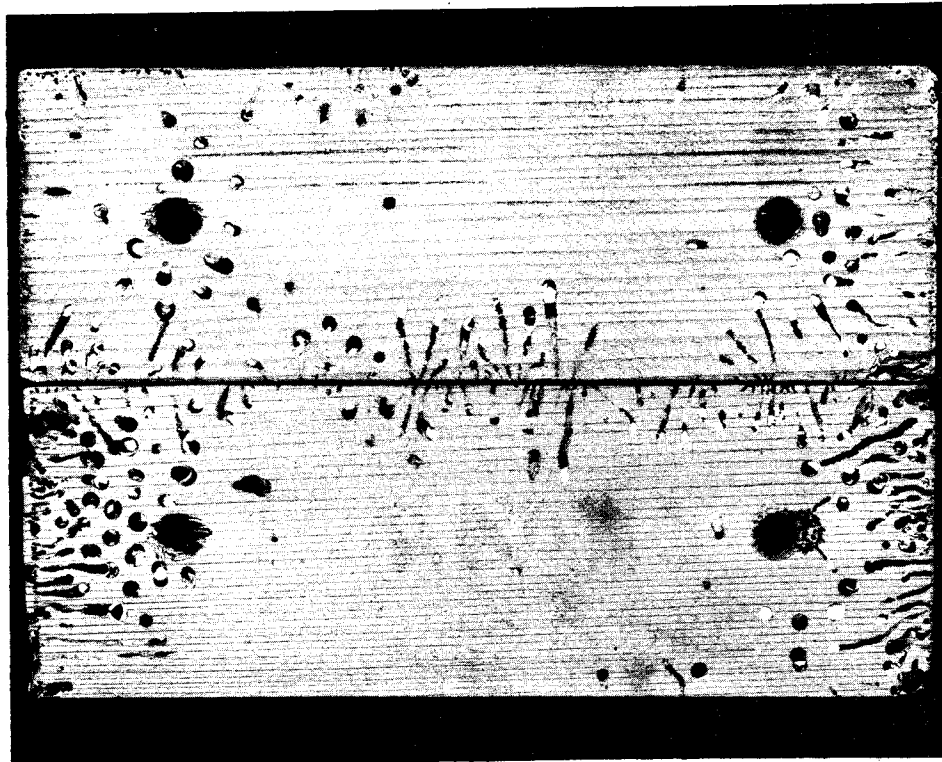
The diameter of the shells of the majority of the borers in these woods measured about 1/8 inch. Some borers in cedar and redwood had penetrated about 3/4 inch into the wood from the cut end of a panel (Figures 18 & 19). The loss in weight of each of these panels due to borer damage is presented in the Appendix.

Figure 18. Closeup view of interior side of cedar (l.) and redwood panels.

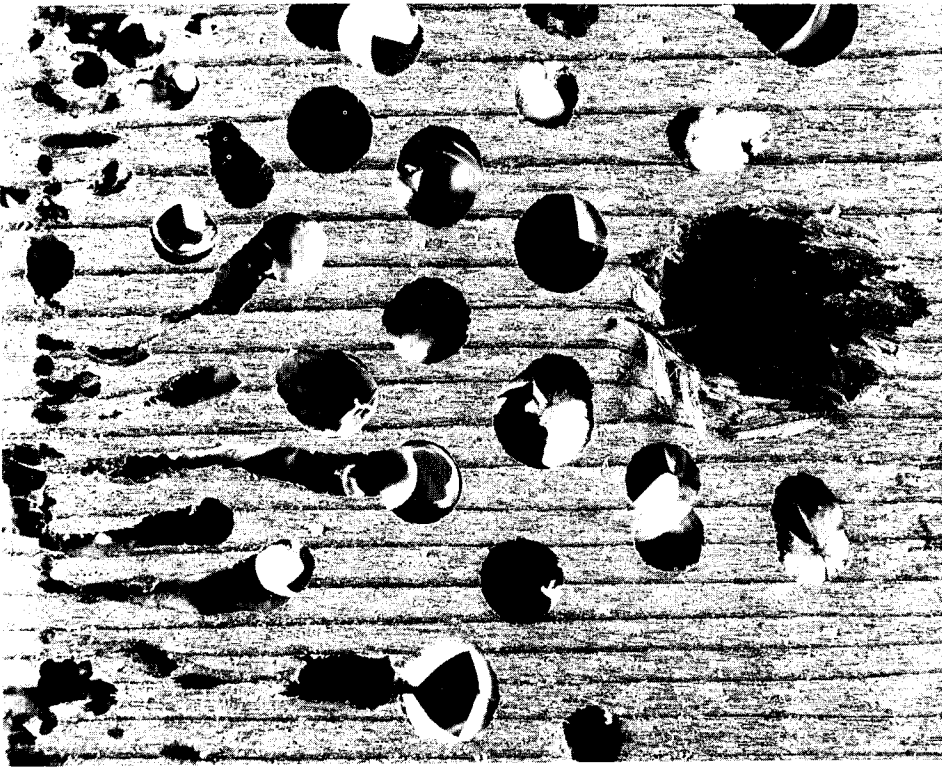
Figure 19. Closeup view of cedar panel showing 1/8-inch-diameter marine borers in holes.

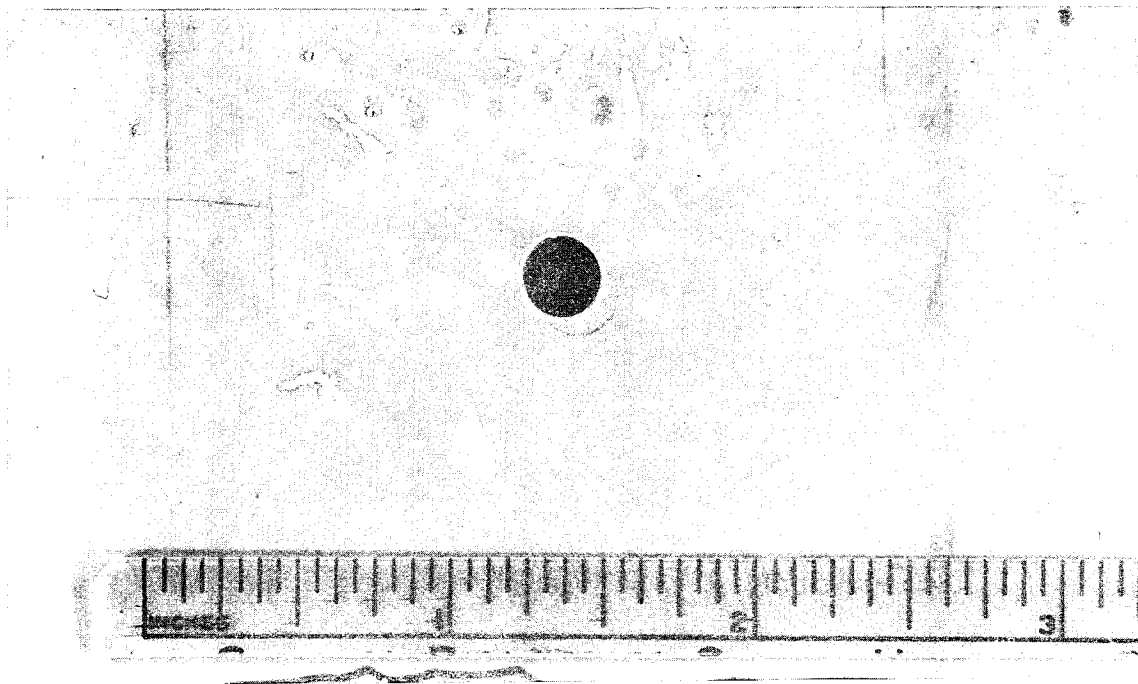
Figure 20. Phenolic laminated plastic sheet damaged by borers in an area which was in contact with wood. Compare size of damage to 1/4-inch-diameter bolt hole.

The surface of the phenolic laminated plastic sheet where the wood panels were attached was damaged by these borers (Figure 20). The borers had attacked the wood first and had then continued to bore into the plastic. Deep sea fungi were not found in any of the 1/2x2x6-inch panels which were exposed about 3 feet above the sediment layer. However, the surfaces of these wood panels were slightly deteriorated by bacterial action.

A phenolic resin plastic sheet (1/8x12x30 inches), onto which smaller test specimens were attached and then secured to the bio-racks, was damaged by borers. The damage was confined to the area where the wood panels were secured to the plastic sheet. The borers had attacked the wood first and had then continued to penetrate into the surface of the plastic sheet.

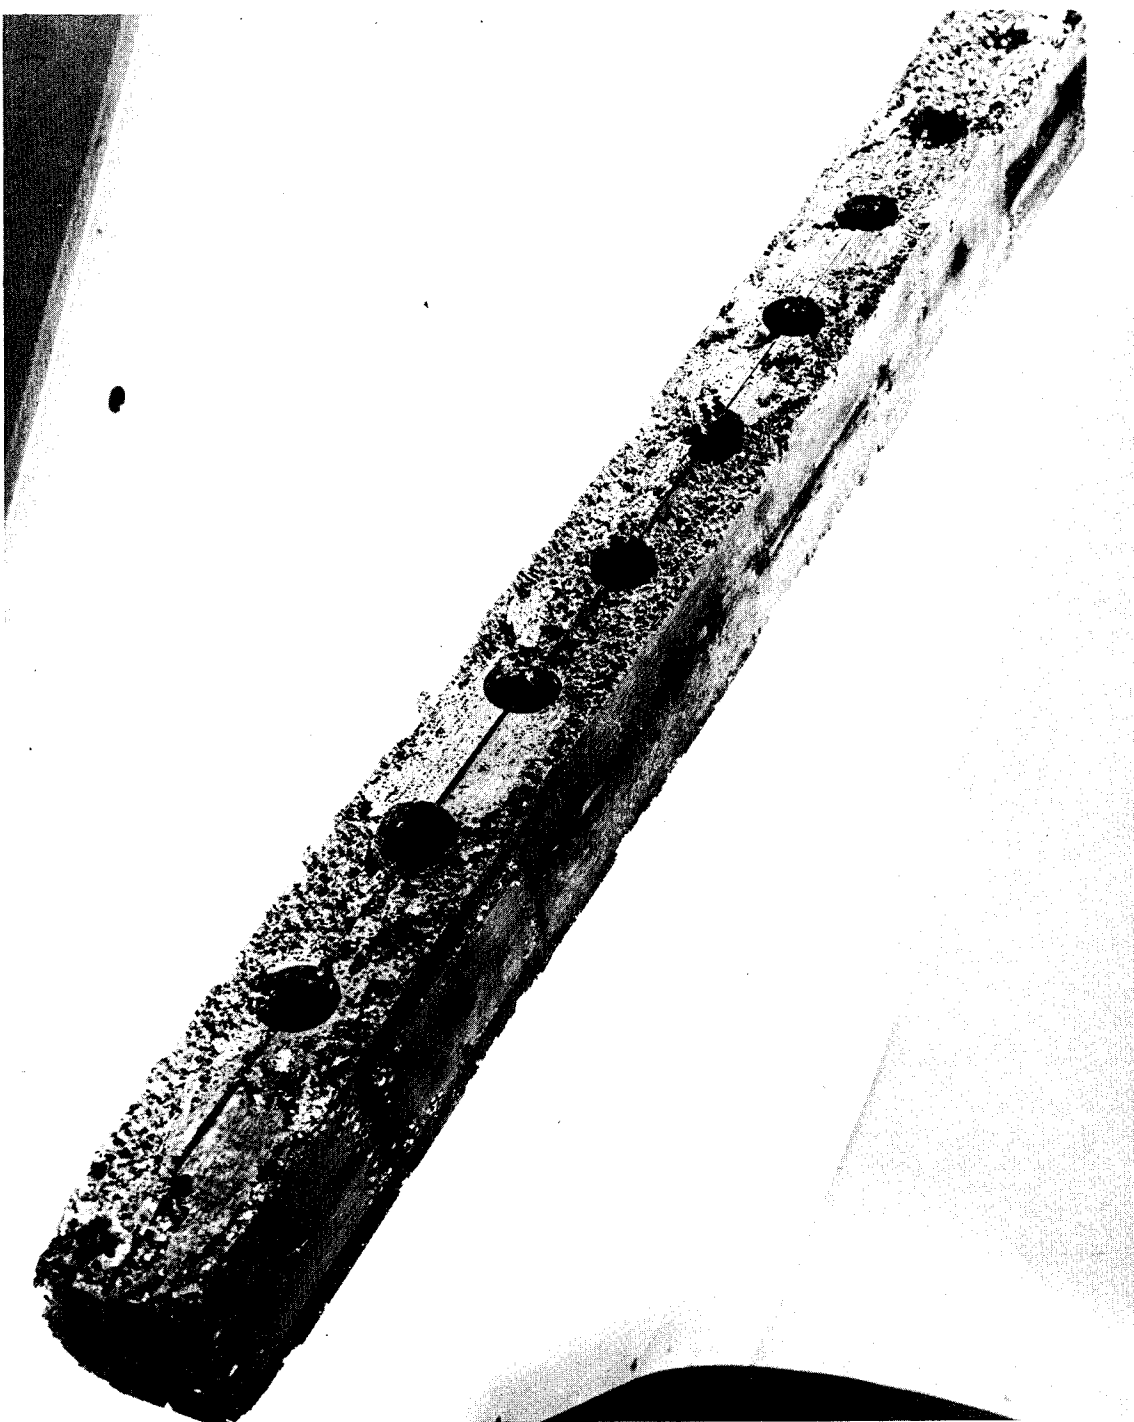
The 2x4x30-inch untreated fir bait pieces which were fitted over the plastic rods and tubes were deteriorated by borers. The heaviest damage was confined to the bottom side of a bait piece exposed right next to the sediment (Figures 21 & 22). Generally the large bait pieces were in fairly good condition, because the borers had not had time to penetrate deeply.

Figure 21. Untreated fir bait piece damaged by borers.

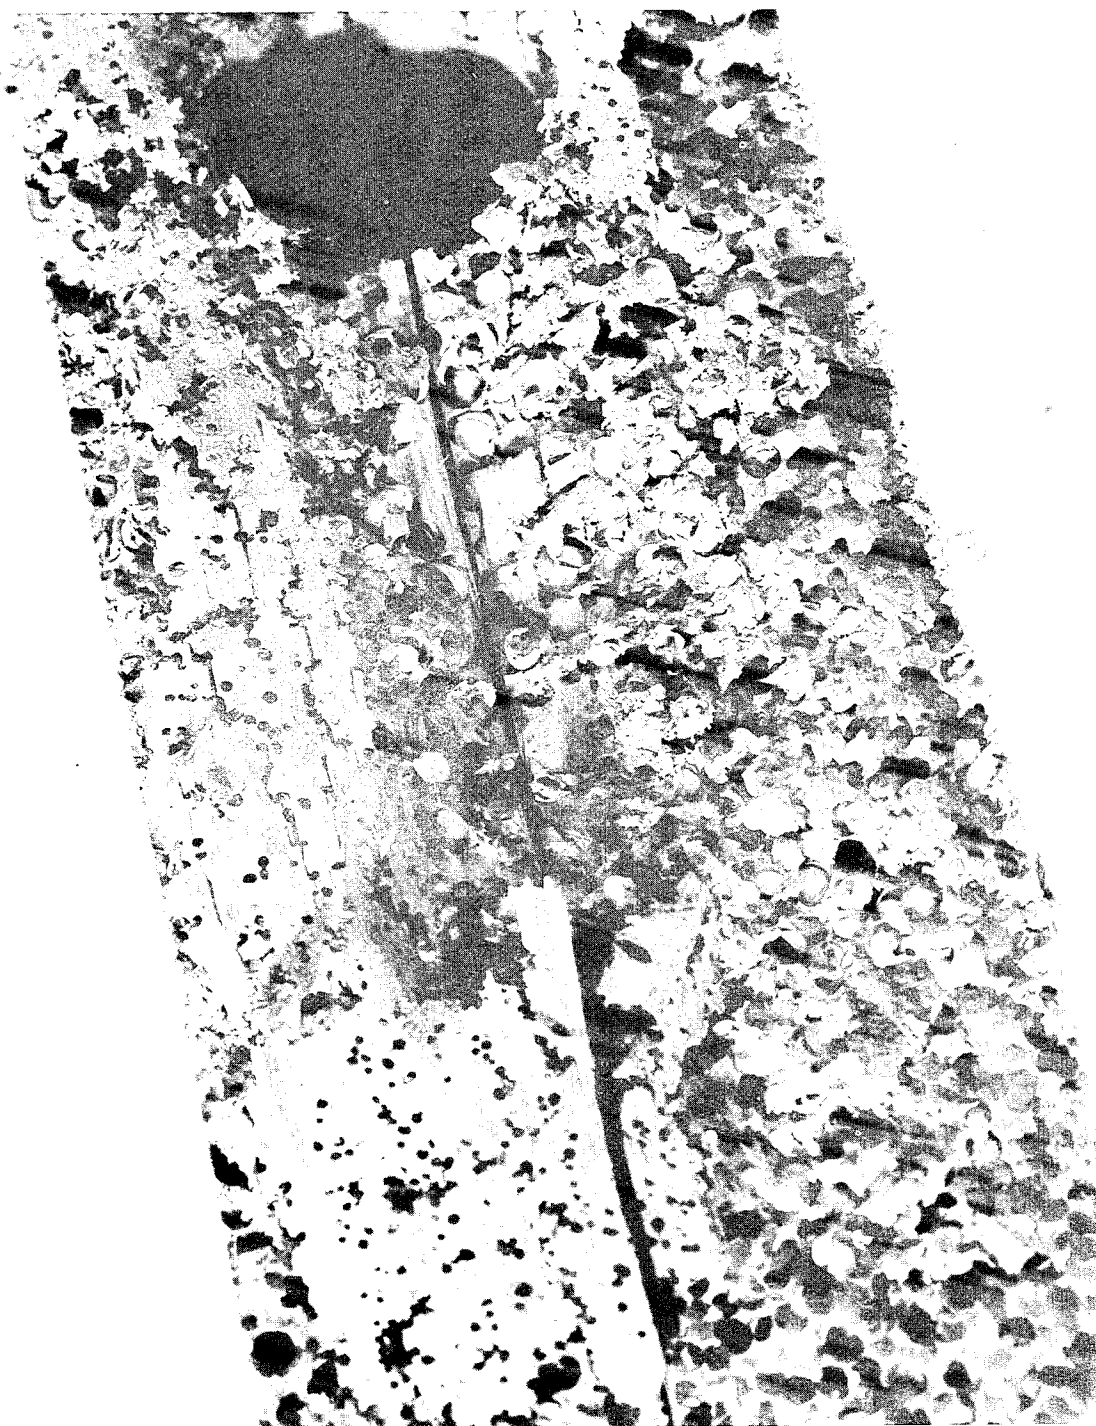
Figure 22. Closeup view of Figure 21 showing borers and borer damage.

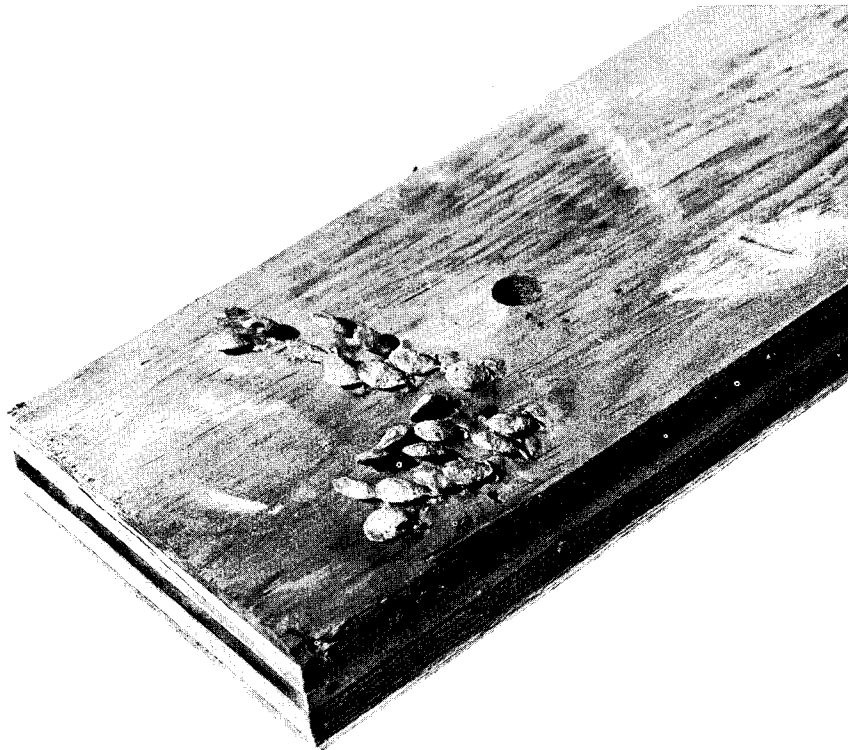
A 3/4x3x36-inch untreated plywood specimen was exposed between 5 and 8 feet above the mud line. As expected, the damage by the borers was very light compared to wood exposed near the mud line (Figure 23). At the lower end of the plywood board were attached clusters of egg sacks of some unknown marine animals (Figure 24).

Figure 24. Cluster of egg cases of unknown animal attached to a plywood board.

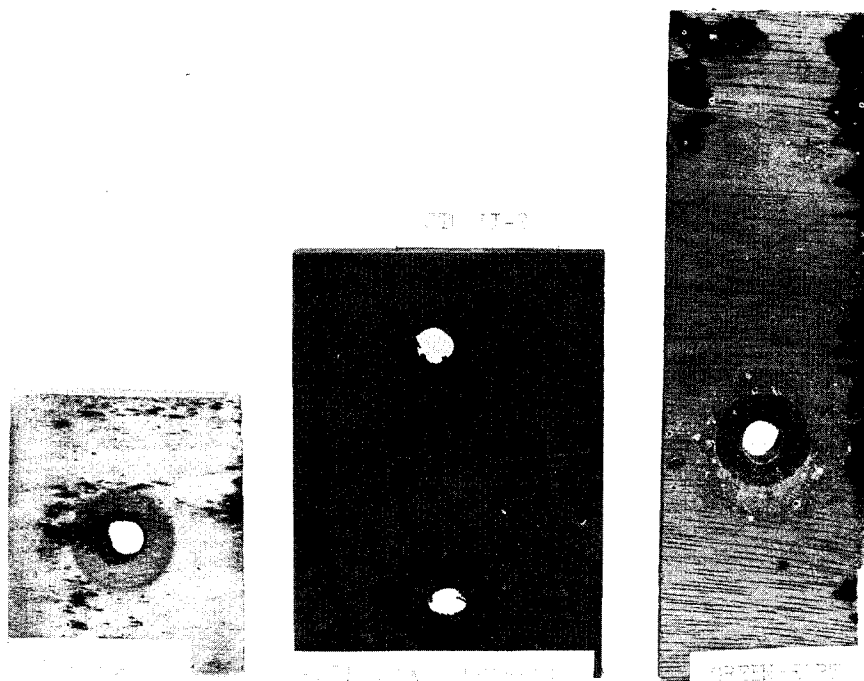
The three tropical wood specimens were attacked by borers (Figure 25). Of these, greenheart sustained the heaviest damage with 14 borers per square inch. The shells of some borers measured about 1/8 inch in diameter, and the borers had penetrated over 1/4 inch into the wood. Afambeau had 7 immature borers per square inch. The borers had penetrated about 1/32 to 1/16 inch. Antidesma was the most resistant of the three tropical wood specimens, with only 2 immature borers per square inch. These borers had penetrated about 1/32 to 1/16 inch. This information was obtained from an examination of a single panel of each of the tropical wood specimens which were exposed about 1 foot above the sediment layer.

Figure 25. Tropical wood specimens (l. to r.) Afambeau, Antidesma pulvinatum, and greenheart.

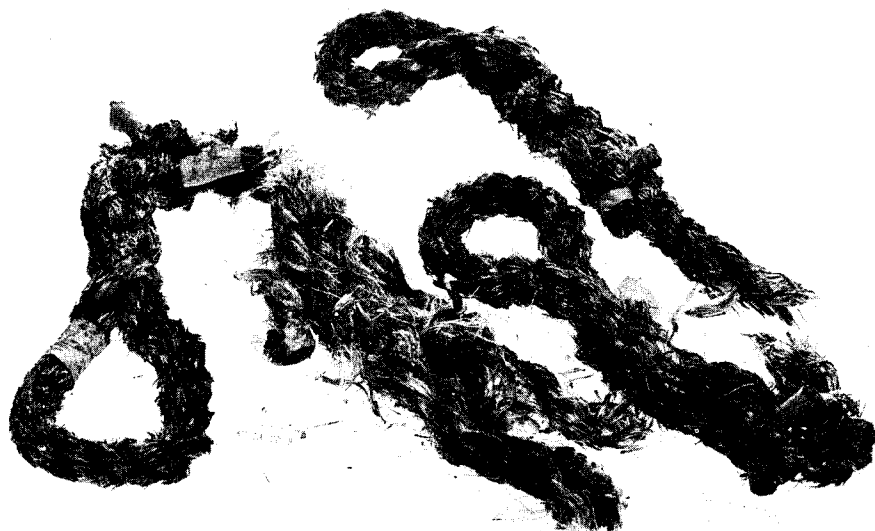
The fibers of cotton were decayed considerably by bacterial action and, as a result, were easily torn apart by one's fingers. The borers were not found on the surface of any of the cotton rope specimens. A test revealed that the cotton rope specimens had lost about 85% of their breaking strength. The 1/2-inch-diameter manila rope specimens were completely destroyed by both borers and microorganisms. Borers ranging in size from 1/32 to 1/8 inch in diameter had completely infested the entire length of the 5-foot-long rope specimens (Figure 26). The rope fibers were severed from deep penetration. The slime bacteria were also responsible for the decay and deterioration of the fiber materials.

Figure 26. Manila rope specimen completely destroyed by the combined action of borers and microorganisms.

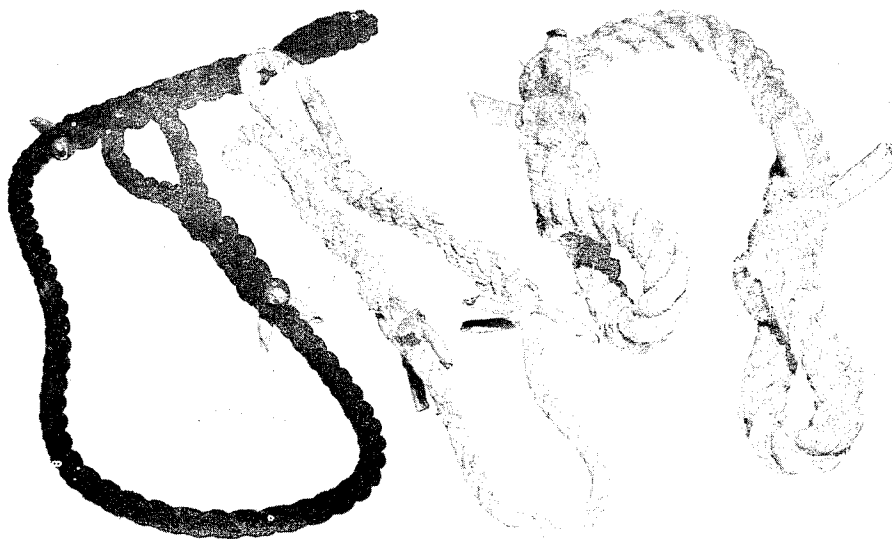
Examination of the nylon and polypropylene ropes under stereoscopic microscope showed that the fibers of these ropes were not damaged by marine borers. On the contrary, they were in very good condition (Figure 27). Table 4 compares the breaking strength of these rope specimens before and after deep sea exposure.

Figure 27. Polypropylene, nylon, and cotton rope specimens.

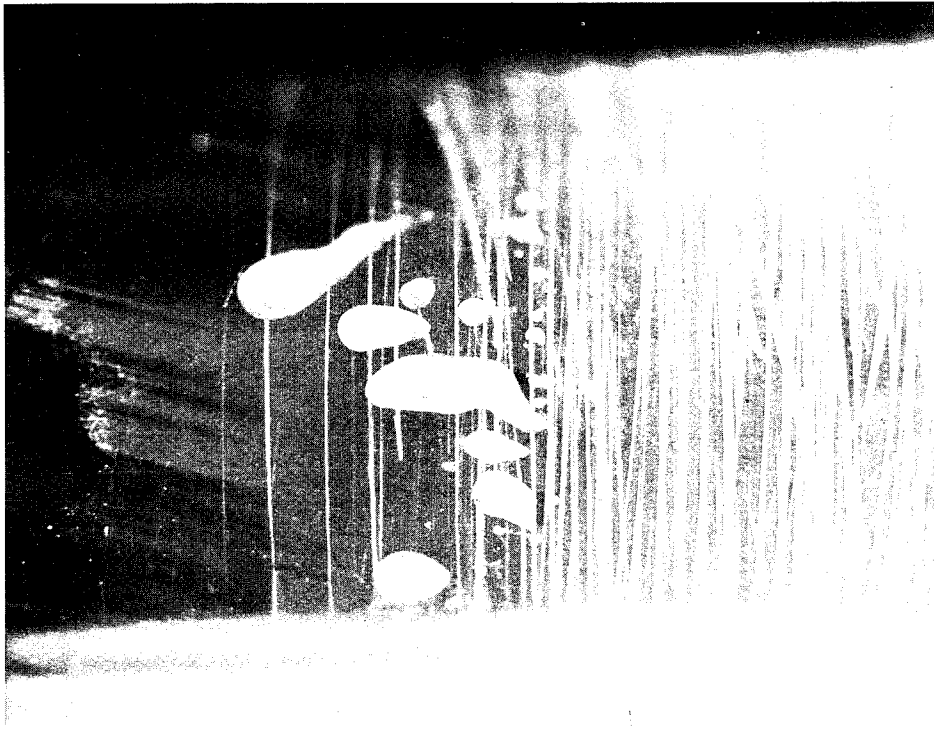
The following plastic sheet, rods, and vinyl tubes were damaged by borers under the wood bait piece: delrin, nylon, phenolic laminates, polycarbonate, Teflon, cellulose acetate, extruded acrylic, polystyrene, and vinyl tubes (NCEL Nos. 424 and 425). Polyvinyl chloride pipe (unplasticized), polyethylene, cast acrylic, and a vinyl tube (NCEL No. 422) were not damaged by borer activity under the bait piece.

Figure 29. Borer damage on the surface of a cellulose acetate rod under area of wood bait piece.

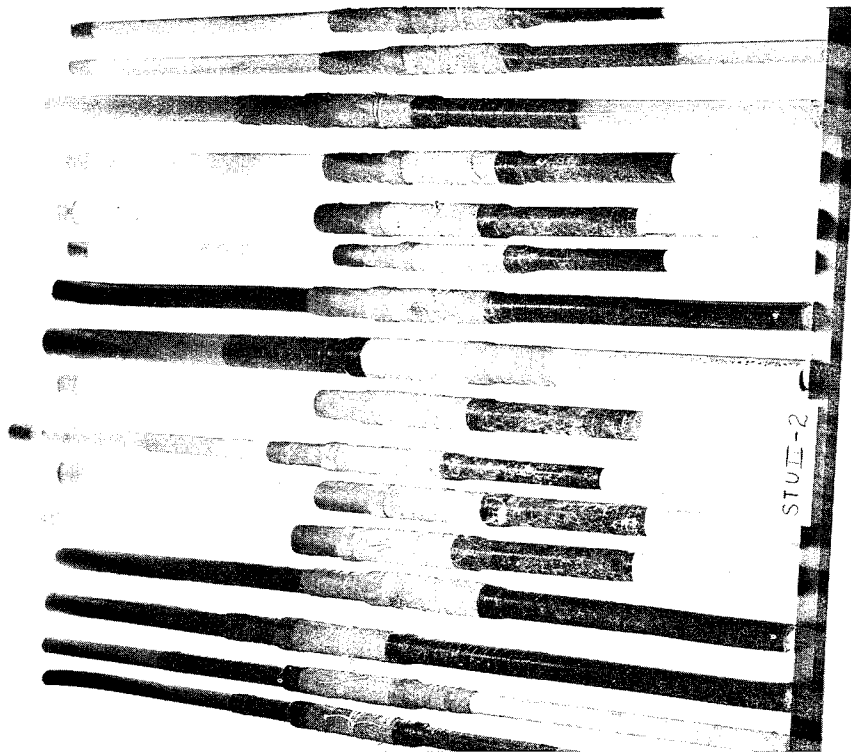
Plastic Specimens. The 3-foot-long plastic rods and vinyl tubes, recovered after 13.4 months on the sea floor in 2,370 feet of water, are shown in Figure 28. There were numerous borer holes, both deep and shallow, underneath the area where the wood bait pieces were fitted over the lower and upper sections of the plastics (Figure 29). Generally, the lower section, exposed about 0.5 to 1 foot above the sediment layer, had more borer holes than the upper sections which were exposed about 3 feet above the sediment. In other words, the borers were found to be more active near the sediment than 3 feet above the sediment layer.

Figure 28. Various types of plastic rods, tubes, pipe, and a rubber vacuum hose with wrappings.

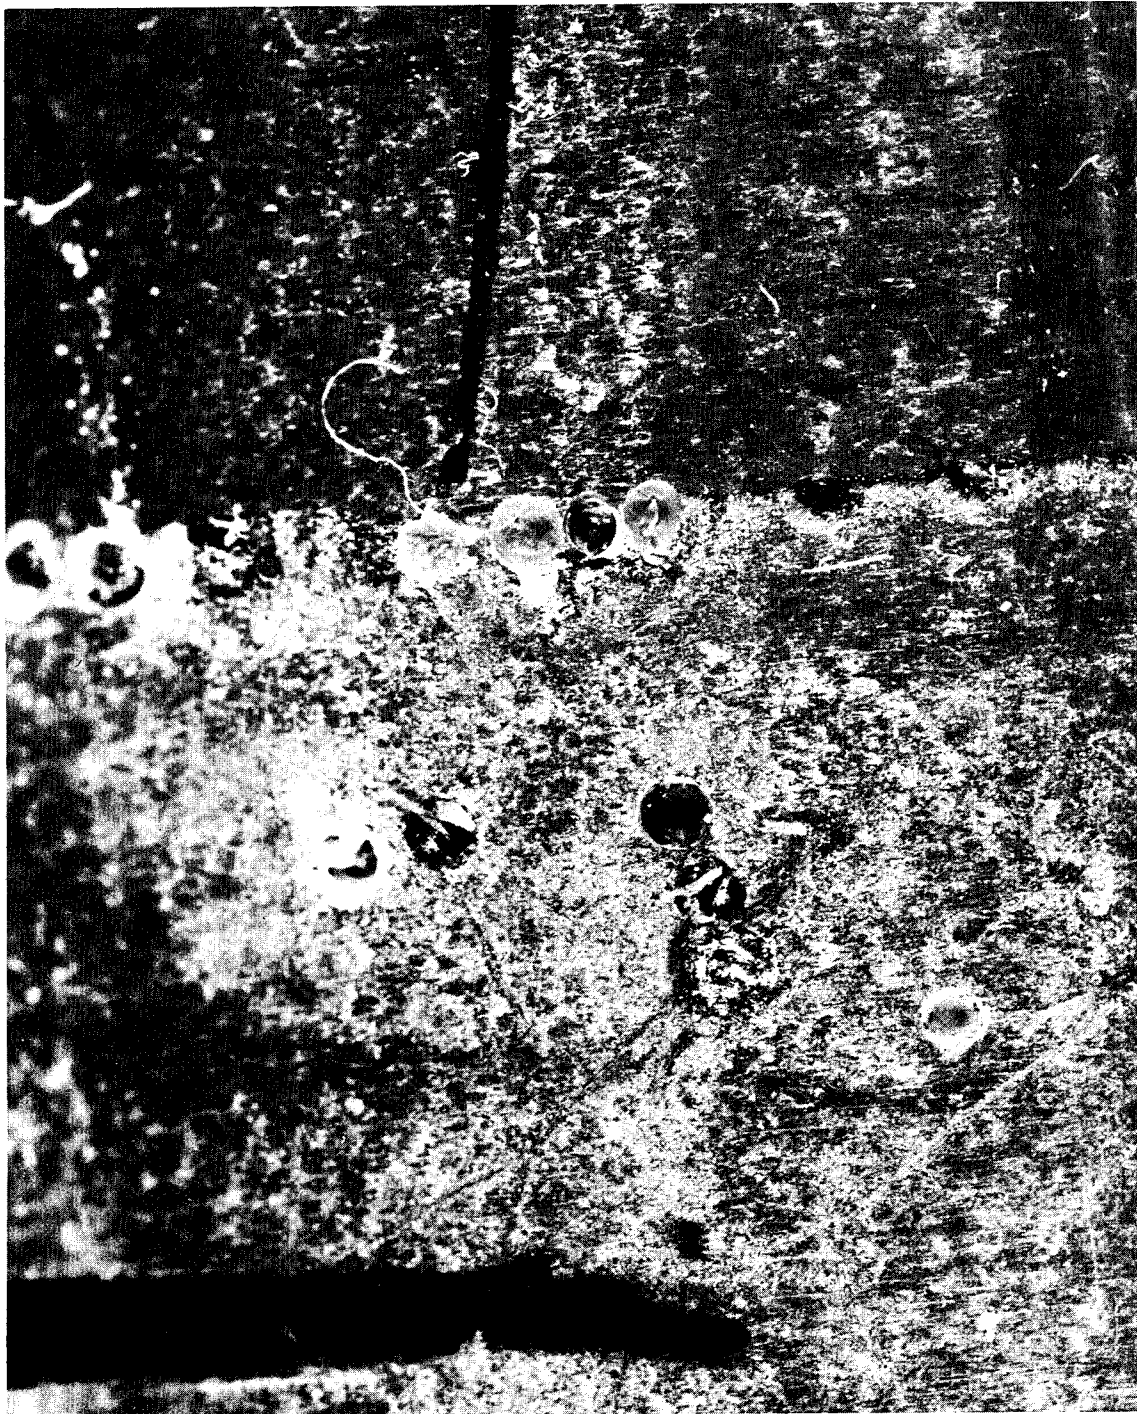
Figure 30. Photomicrograph of borer damage on the surface of a polystyrene plastic rod. The 1/32-inch-diameter borers are visible in holes.

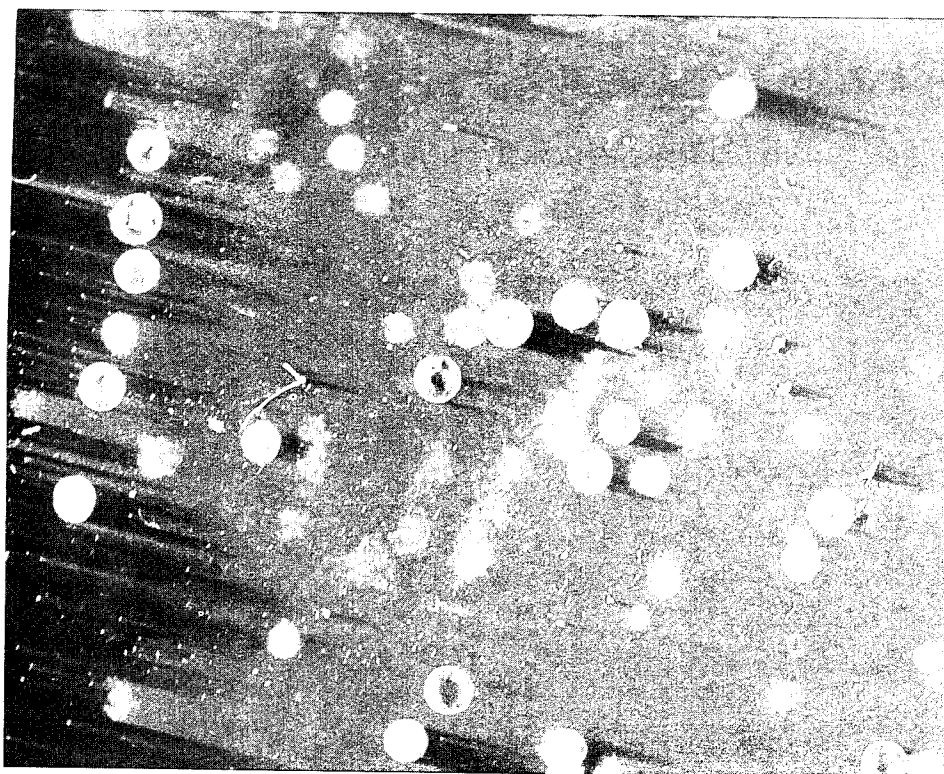
Figure 33. Photomicrograph of borer damage on surface of a vinyl tube. Some of the borer holes are about $1/32$ inch in diameter and about $1/32$ inch deep.

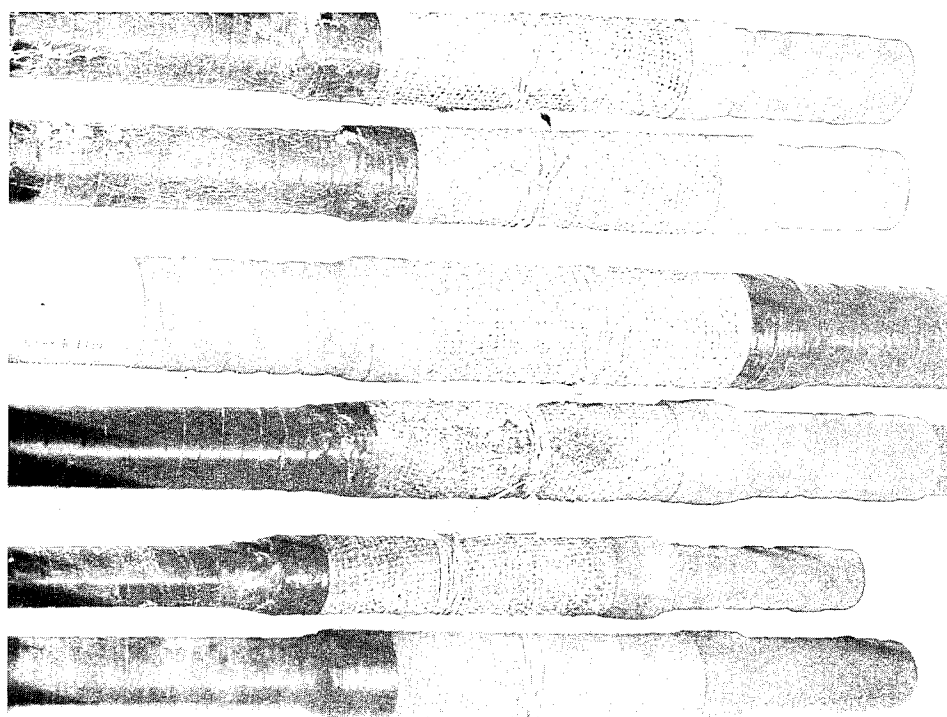
Wrappings Around Plastics. The burlap wrappings were moderately deteriorated by microbial activity, and the material could easily be torn apart by hand. The rubber electrical tape wrappings were not affected by marine organisms, although there was a light hydroid growth on the rubber material. Slight cracks were present in the rubber, and these were probably produced by the effects of the deep sea environment. The plastic tape wrappings were not affected by marine borers; however, there was some hydroid growth on them (Figure 34).

Figure 34. Rubber tape, burlap (jute), and plastic tape wrappings over plastic rods and pipe.

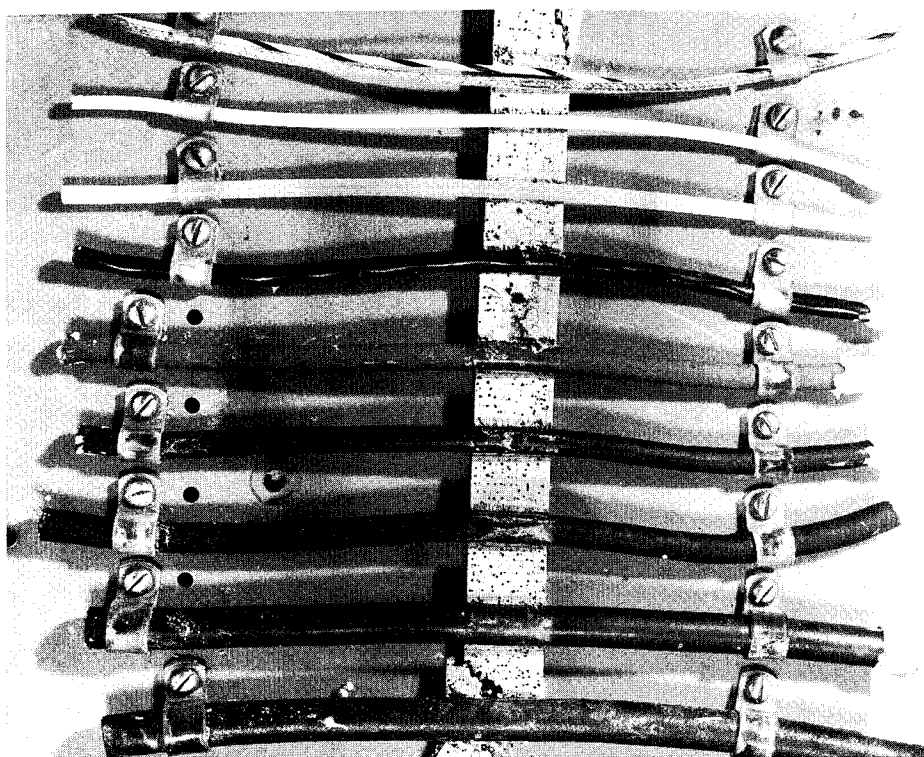
The wood bait pieces were riddled by the borers. However, only silicone rubber insulation and polyethylene insulation were damaged by borer activity under the bait piece exposed near the sediment, and that damage was slight. The other insulations, such as butyl rubber, neoprene rubber, natural rubber, polyvinyl chloride, nylon, fluorinated ethylene propylene (FEP) and Teflon were unaffected by animal activity or by the deep ocean environment (Figure 35).

Figure 35. Single and multiconductor electrical cable insulations in contact with wood bait piece.

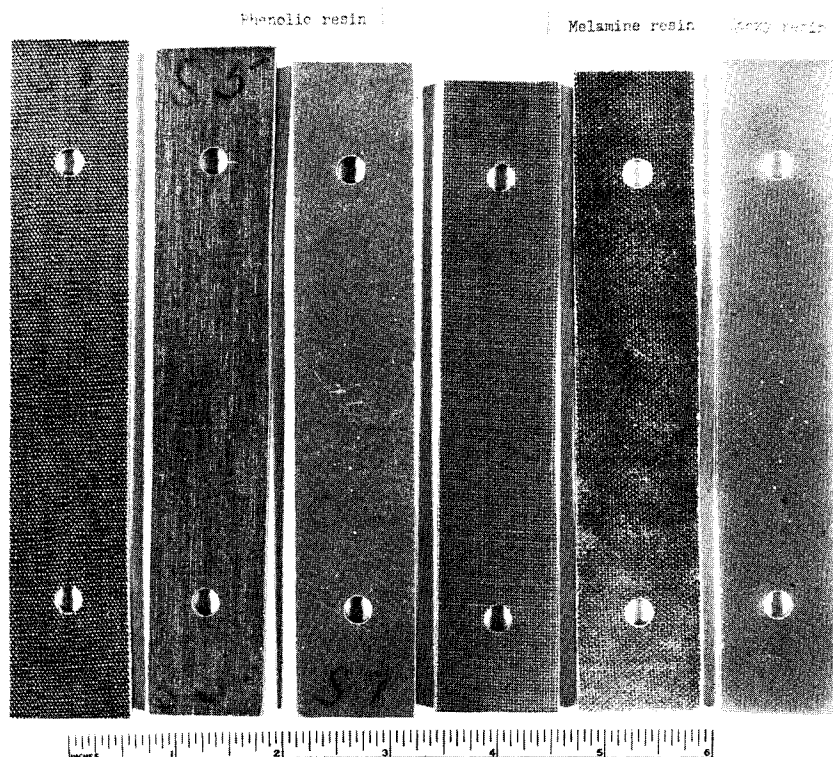
Laminated Plastics. The phenolic, epoxy, and melamine resin laminated plastic specimens were not damaged (Figure 36). The results of moisture absorption and hardness tests conducted on these materials are presented in Table 5.

Figure 36. Phenolic, epoxy, and melamine resin-filled laminated plastics.

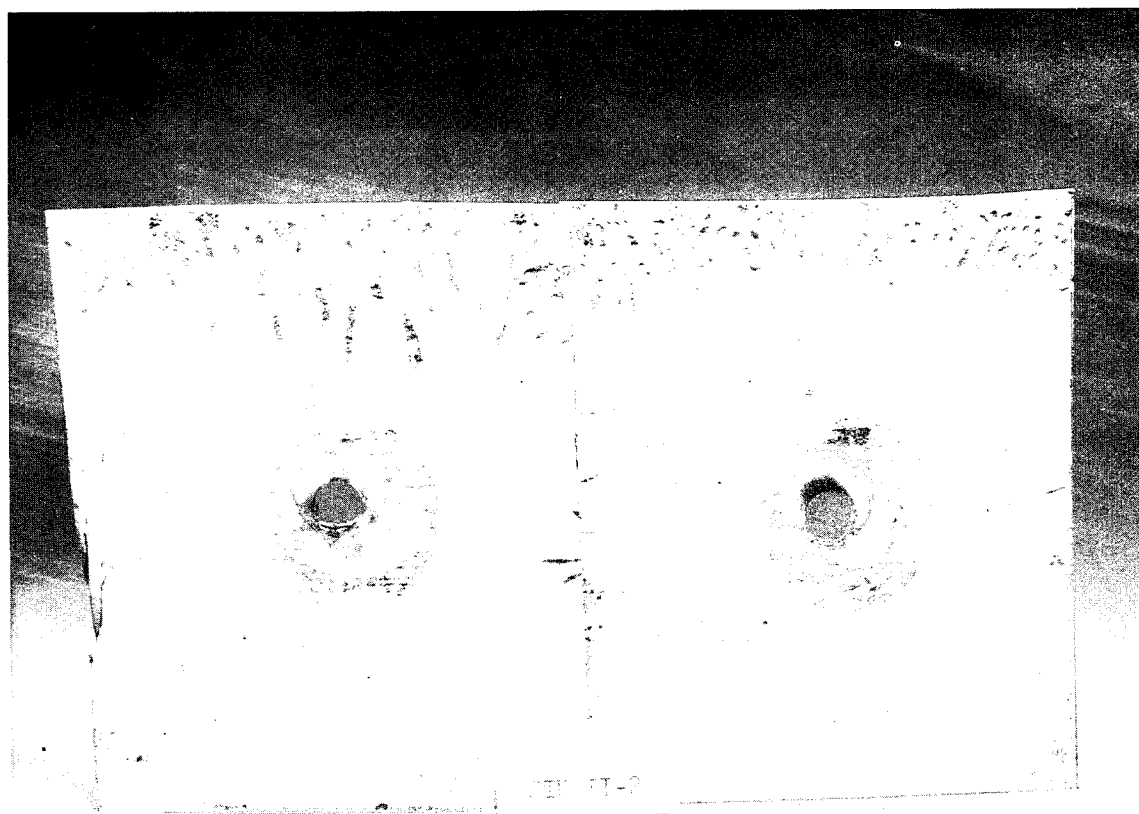
Plastic Sheet. A 0.020x4x4-inch white, high-impact styrene sheet which was used as a spacer between the large wood bait piece and the metal bio-rack was damaged by borers (Figure 37).

Figure 37. Borer damage to 20-mil-thick high-impact styrene sheets which were in contact with wood bait piece.
